DRAINAGE PROBLEMS CHAPEL HILL, AYLBURTON / FEB 2025

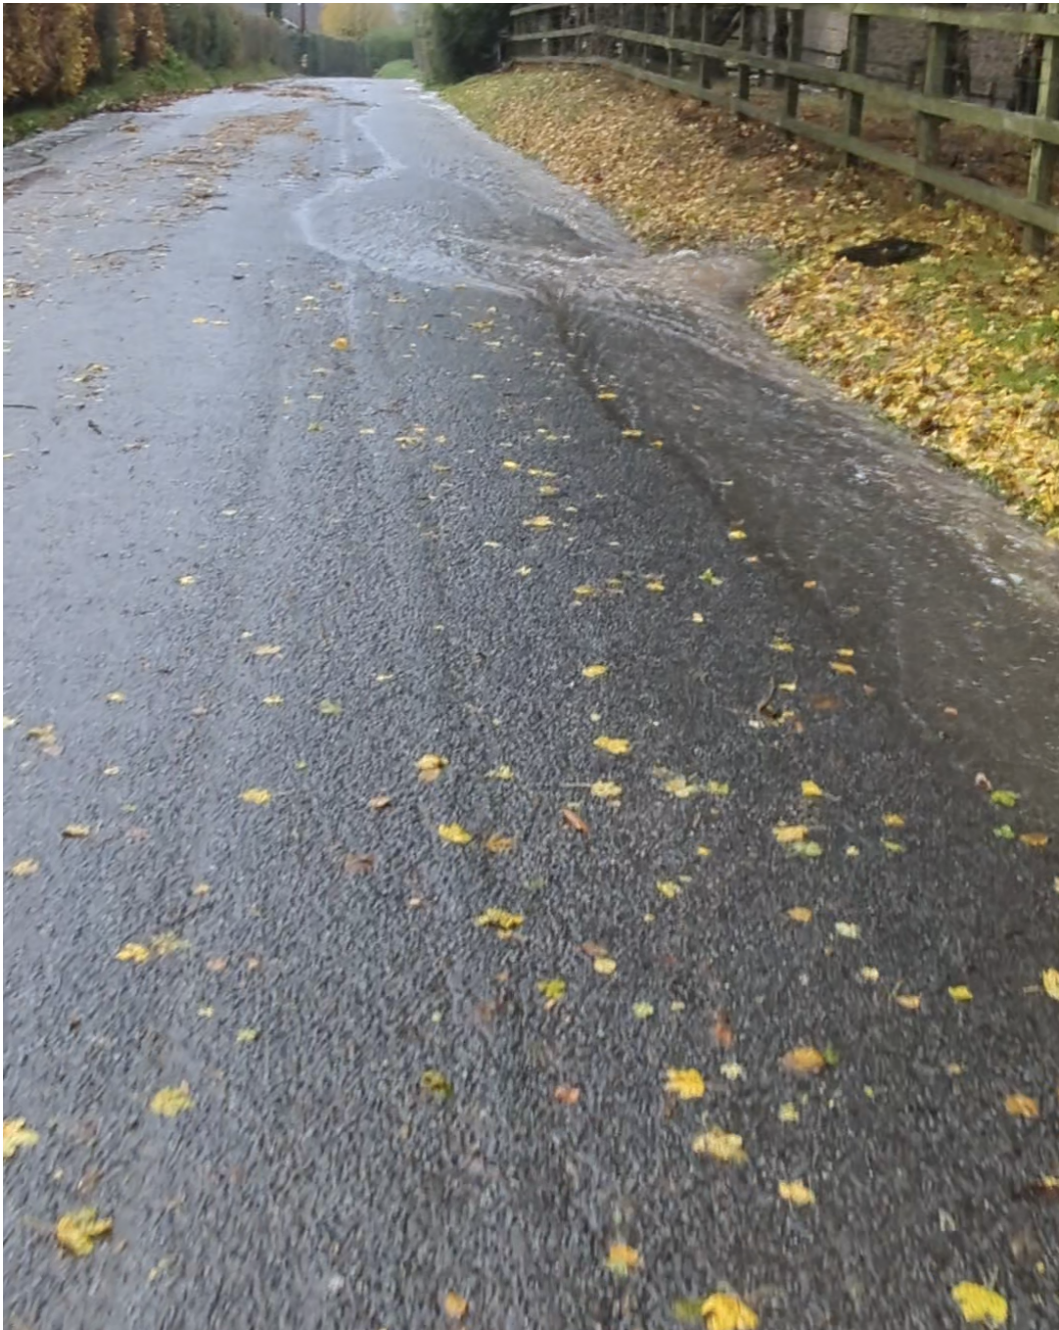
1. A partial blockage between the drain at `///pampering.vivid.grades` and the drain at `///rested.nothing.ecologist`. This has been reported many times. The problem here seems to be that the blockage is only a partial blockage and not located at either manhole cover location, but somewhere in between. Having spoken to the people sent out by Highways to look at it, they told me that the problem is "if it's not over-flowing at the time we come to inspect it then we have to pass it working OK". But as it's only a partial blockage, it might appear to be running without any problems 90% of the time. Below is a picture showing what happens when we get heavy rain for a few hours. My guess is that the partial blockage is located at `///lift.saddens.valve` as this is the location where Severn Trent water dug up the road in 2018 to install a new water connection, but that is just an educated guess.

The drain at [///pampering.vivd.grades](http://pampering.vivd.grades) - this is happening at least every month at the moment. In dry spells, the drain will appear to be running freely.

Solution: Find the partial blockage and clear it.

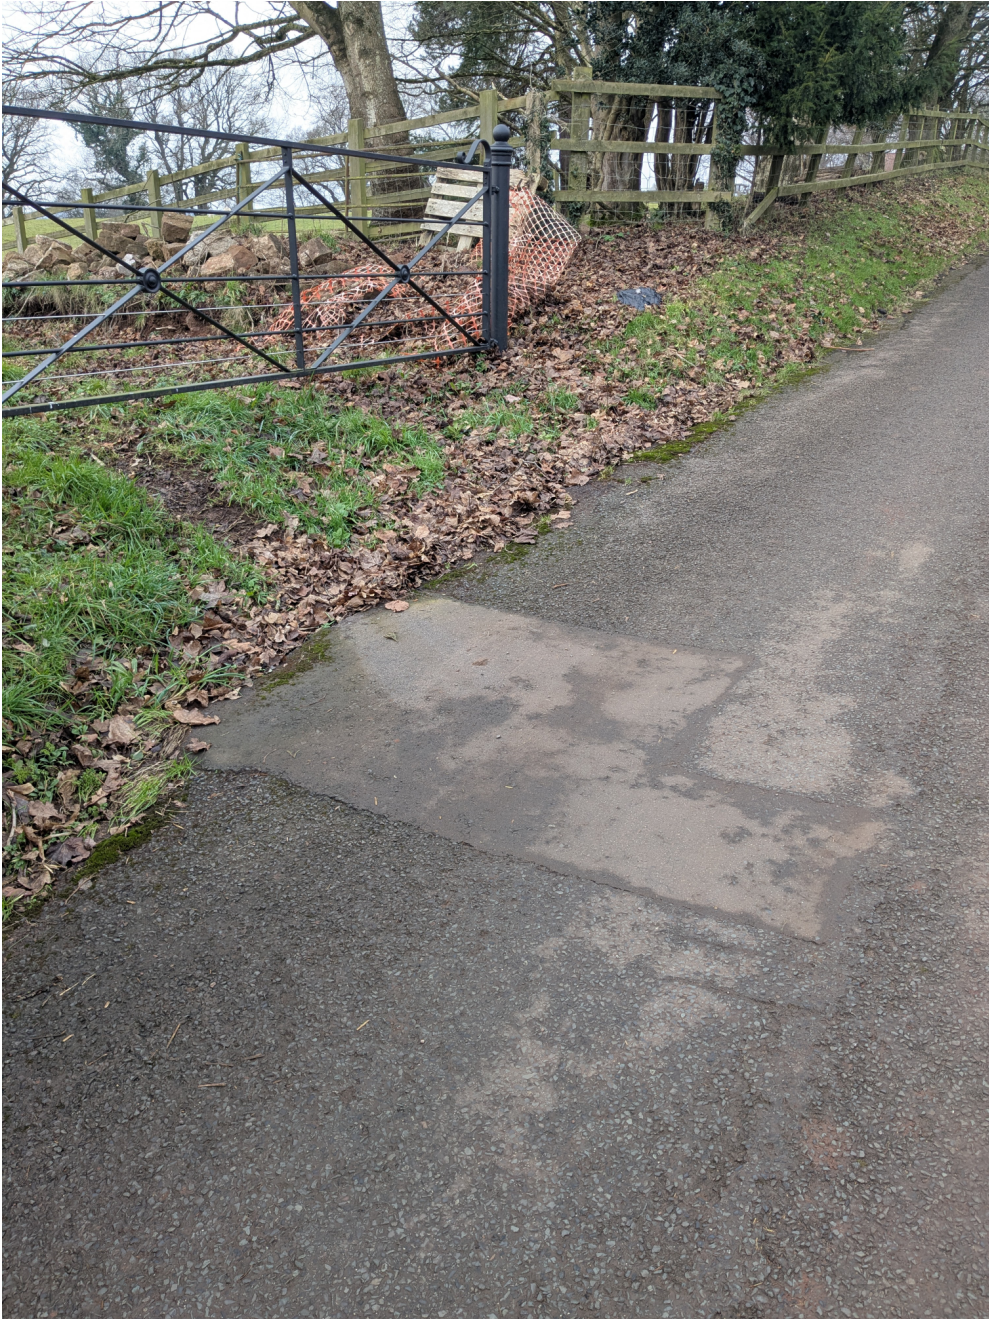
Suspected location of partial blockage [///lift.saddens.valve](#) - you can clearly see where Severn Trent Water dug up the lane to install a new water connection. It is directly above the drainage channel.

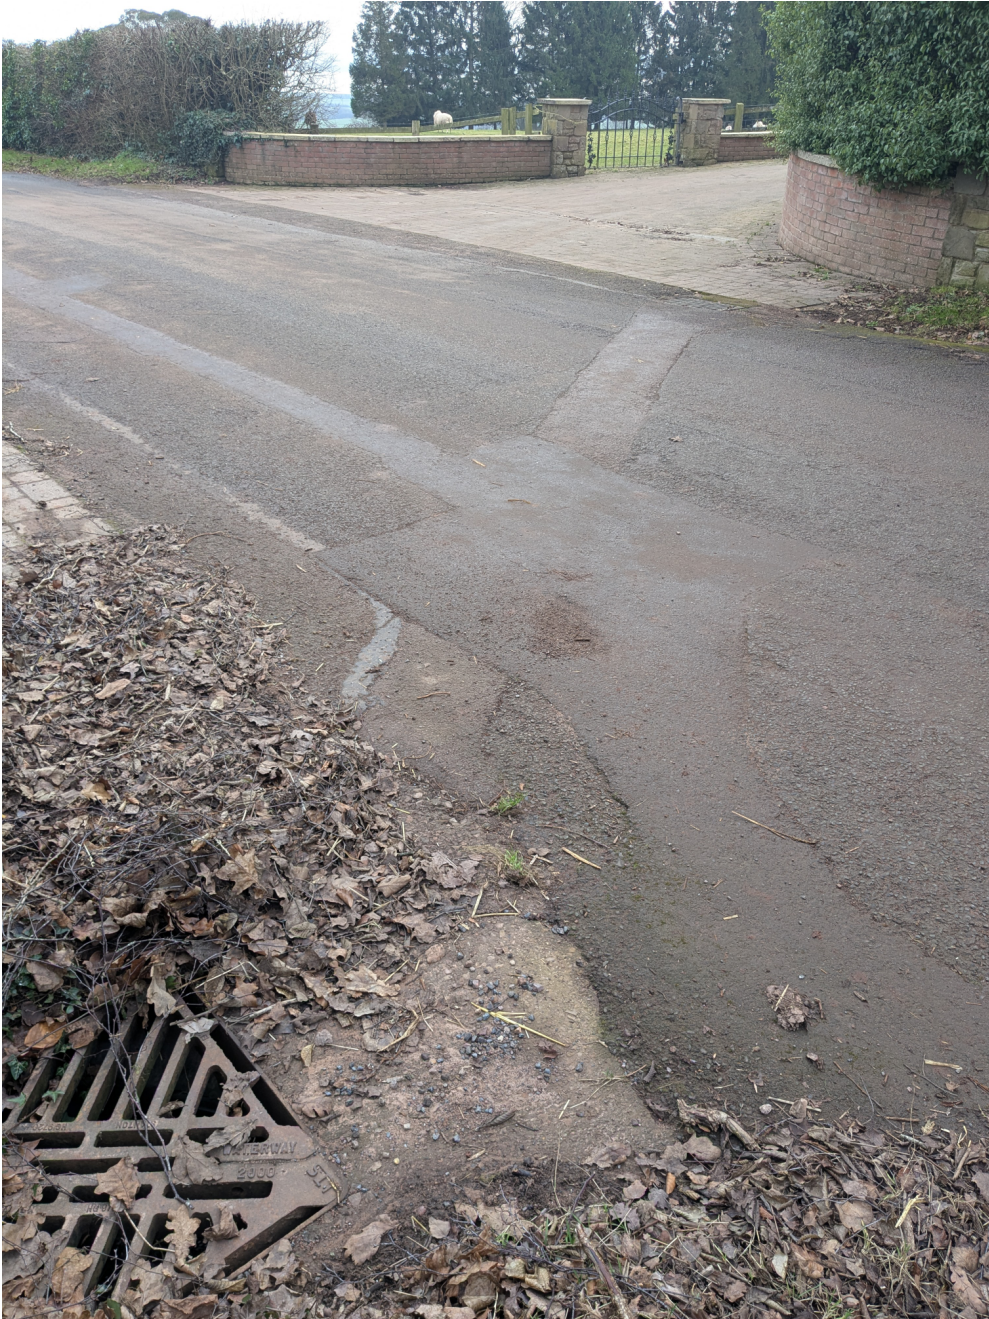
It appears that at some point all the water from the north side of the lane was diverted across to the south side. This is from the drain at [///channel.climate.devoured](#) to the drain at

///jets.stiletto.evidently. (which regularly overflows as it cannot handle the additional flow. The drain at ///channel.climate.devoured also smells strongly of sewage and during heavy periods of rain appears to leach sewage onto the lane. This all adds further pressure to the drainage problem in point 1.

The drain at ///channel.climate.devoured diverted across to ///jets.stiletto.evidently - the tarmac repair shows the diversion clearly.

Solution: Reinstate and clear the diverted drains on the north side of the lane.
